FULL RESERVE STUDY

*DEVAUN PARK
CALABASH, NC*

*Prepared for:
DEVAUN PARK COMMUNITY ASSOCIATION
CALABASH, NC
&
CAS, INC.*

JUNE 3, 2016

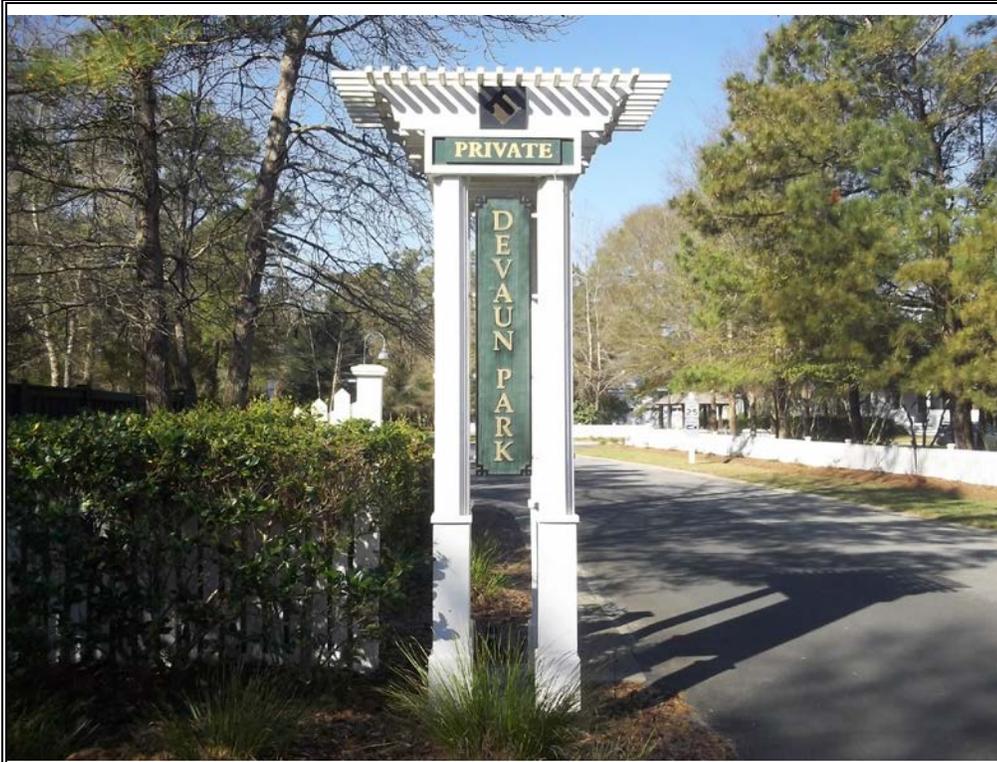
Photo Number
1

Description:
Entrance signage,
typical

We noted 2 separate areas of entrance signage, at Shady Forest Drive and at Ocean Harbour Golf Club Drive. The entrances include painted wood posts and arbors, and painted signs. Lighting is provided. We have included funds to paint and make repairs to the entrance signage every 5 years beginning in 2020, with surplus funds to replace the lighting every 15 years.

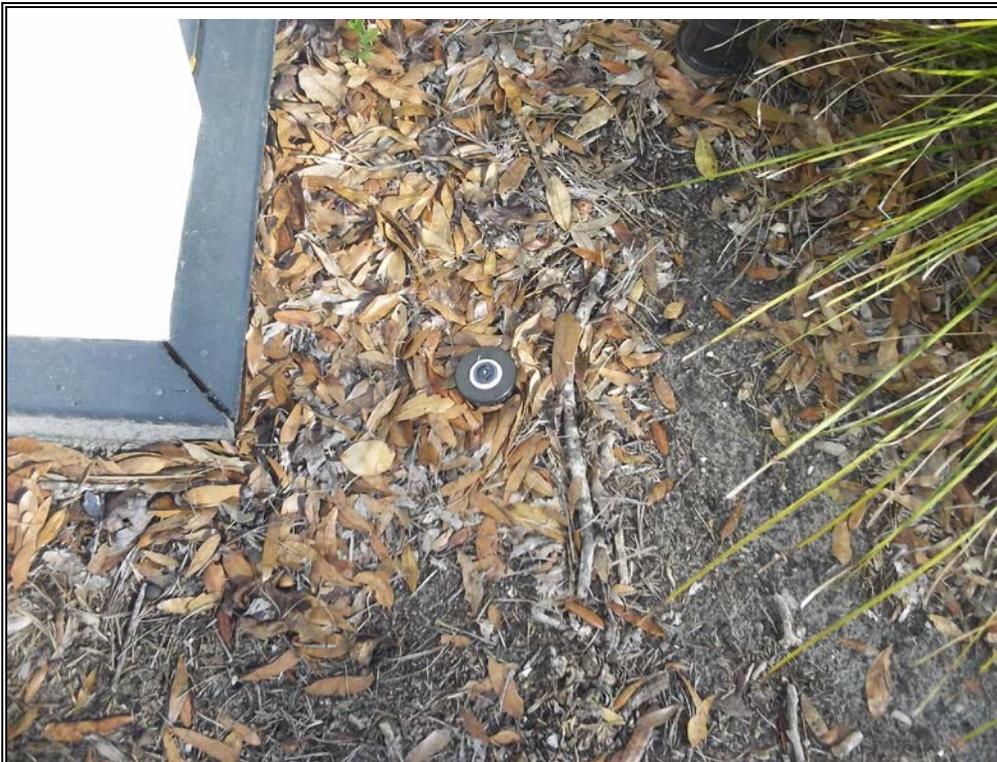
Photo Number
2

Description:
Irrigation at
entrance

Though an irrigation map was not available, we noted irrigation in several areas, including the entrances and clubhouse. We have included funds to replace the controllers, timers, and limited sections of sprinkler heads and tubing every 8 years beginning in 2021.

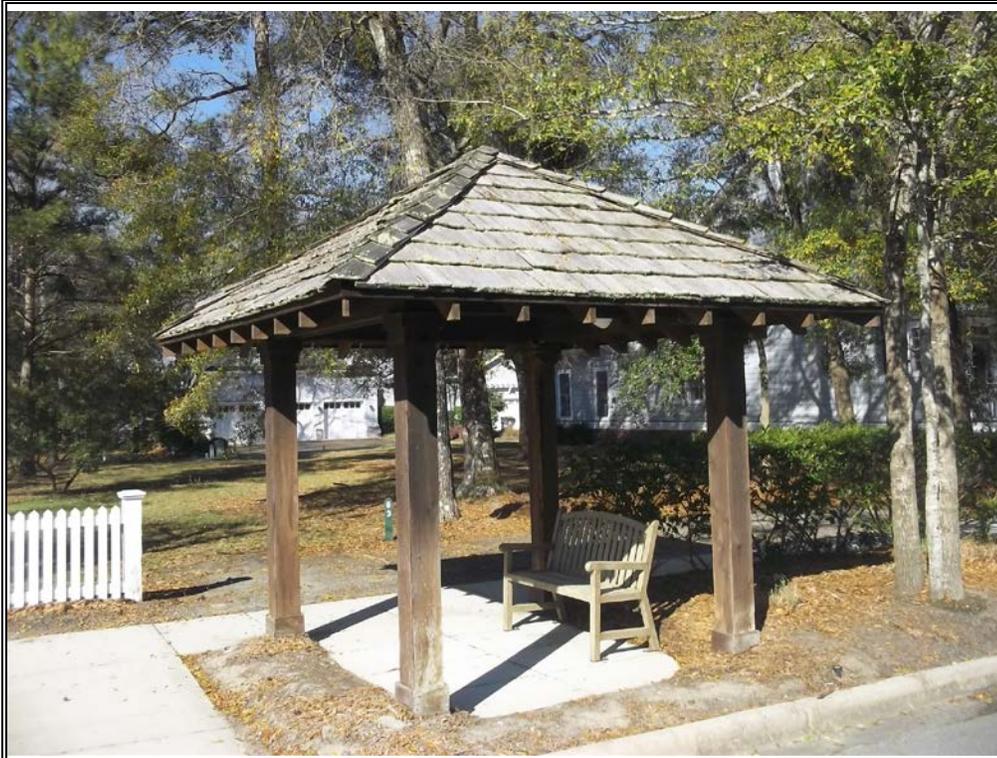
Photo Number
3

Description:
Typical shelter

Four total gazebos/open air shelters were noted in the community, at Shady Forest, Devaun Lake, Whisper Park, and Devaun Pointe. They are wood framed and painted or stained, with wood shingle roofs except the Devaun Pointe shelter has a standing seam, metal roof. Two pergolas were noted at Riverside Park and include a swing. These structures will require painting and minor repairs, approximately every 5 years. We have provided an allowance for this beginning in 2019. We have assumed the wood shingle roofs will be replaced with standard asphalt shingles. We expect the replacement beginning in 2025 and every 20 years thereafter.

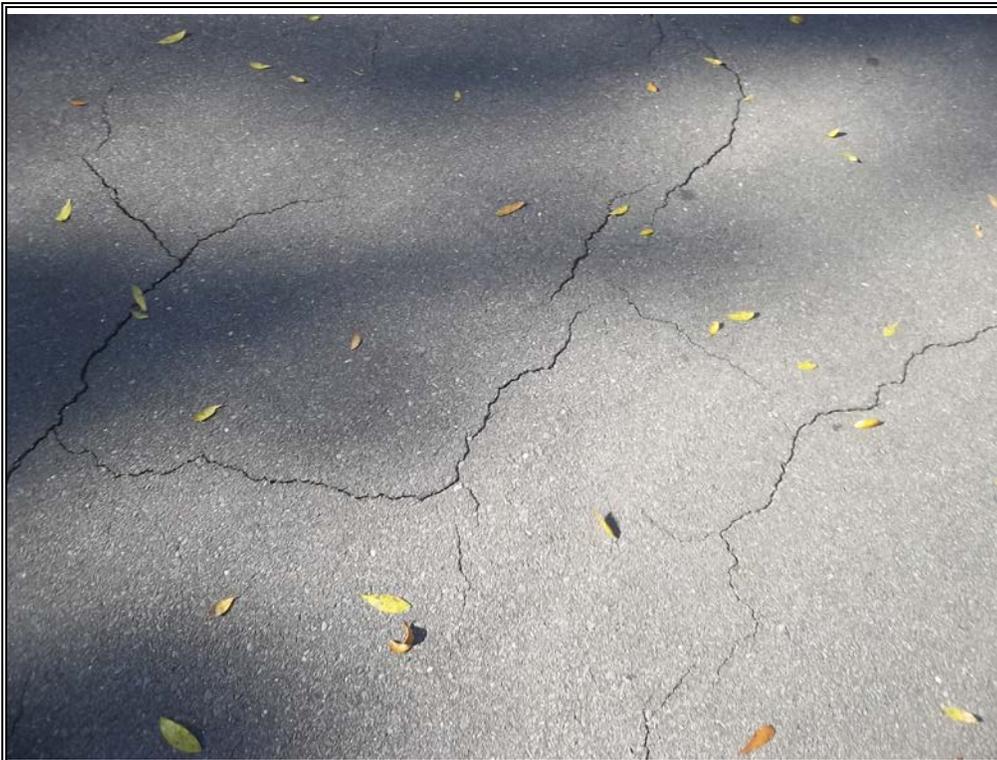
Photo Number
4

Asphalt pavements in a residential setting has a typical expected useful life of approximately 25 years. The asphalt cracking and deterioration observed matches a pavement of 10+ years. We have included funds for resurfacing in two phases, beginning in 2032 and continuing in 2035. As part of resurfacing, we have included funds to mill and replace the top 1-1/2" of pavement and install a new surface course of the same thickness.

Description:
Typical asphalt
cracking

The streets throughout the community are asphalt paved and are maintained by the Association per our understanding. A portion of the community west of Devaun Park Boulevard and Village Square remains unpaved and has not been included in this reserve study. The streets generally appear to be in good condition for the given age. We noted several areas of linear cracking and limited areas of fatigue cracking, with no previous repairs noted. Over time, as the pavement oxidizes and traffic increases, cracking will accelerate and require full depth asphalt patching. This would include saw cutting and removing sections of failed asphalt, repairing base course/sub-grade as needed and installing new 2" to 4" thick asphalt paving. We have provided funds for making asphalt patching every 5 years beginning in 2022.

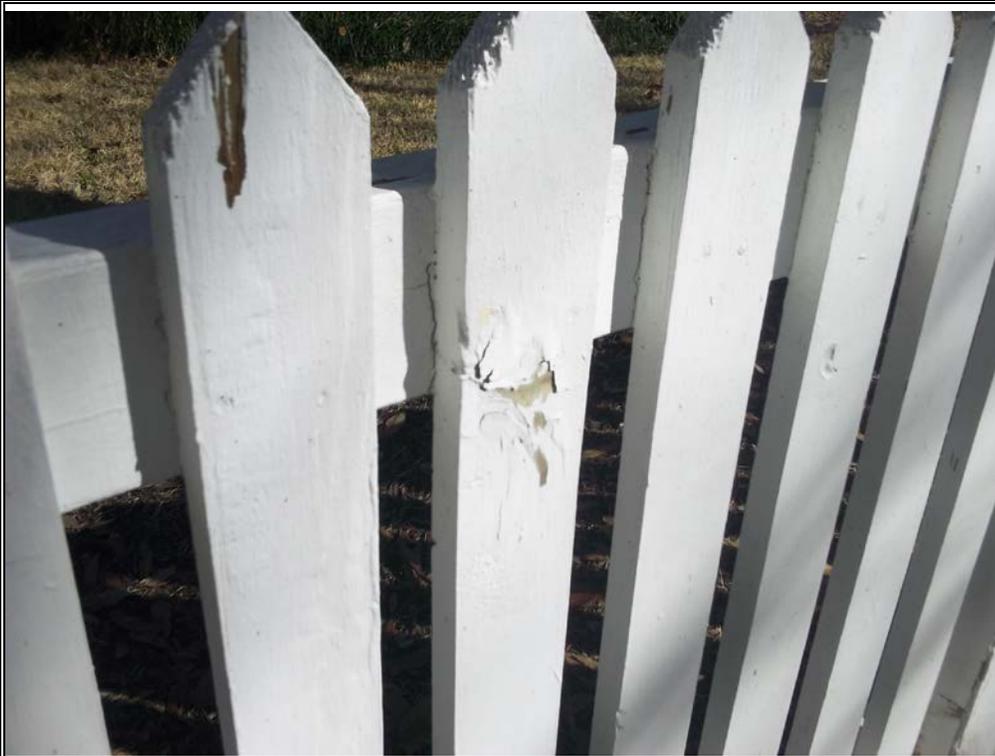
Photo Number
5

Description:
Painted picket
fence

Painted wood picket fence is located along Devaun Park Boulevard, and painted wood privacy fence is located along the eastern property line adjoining neighboring areas. Painted wood fence is also located at the clubhouse. Per discussion with the Board, the Association paints the fence as needed. We have provided an allowance for continued painting as required every 3 years beginning in 2020, assuming roughly 1/3 of the fence is painted during each cycle. If painting continues, replacement of the fence will likely be required for sections of the fence approximately every 15 years. We have included funds to replace about 1/2 of the fencing beginning in 2030. Replacement of individual boards will likely be required over the term, and should be funded from the general operating budget.

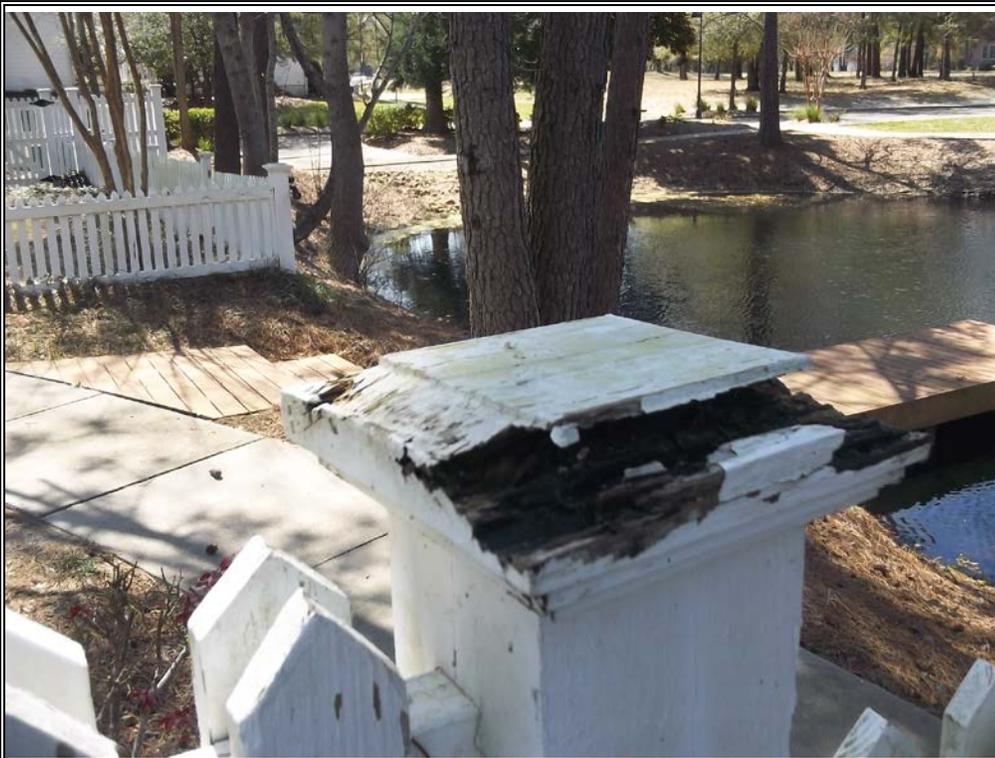
Photo Number
6

Description:
Moderate
deterioration at
wood fence

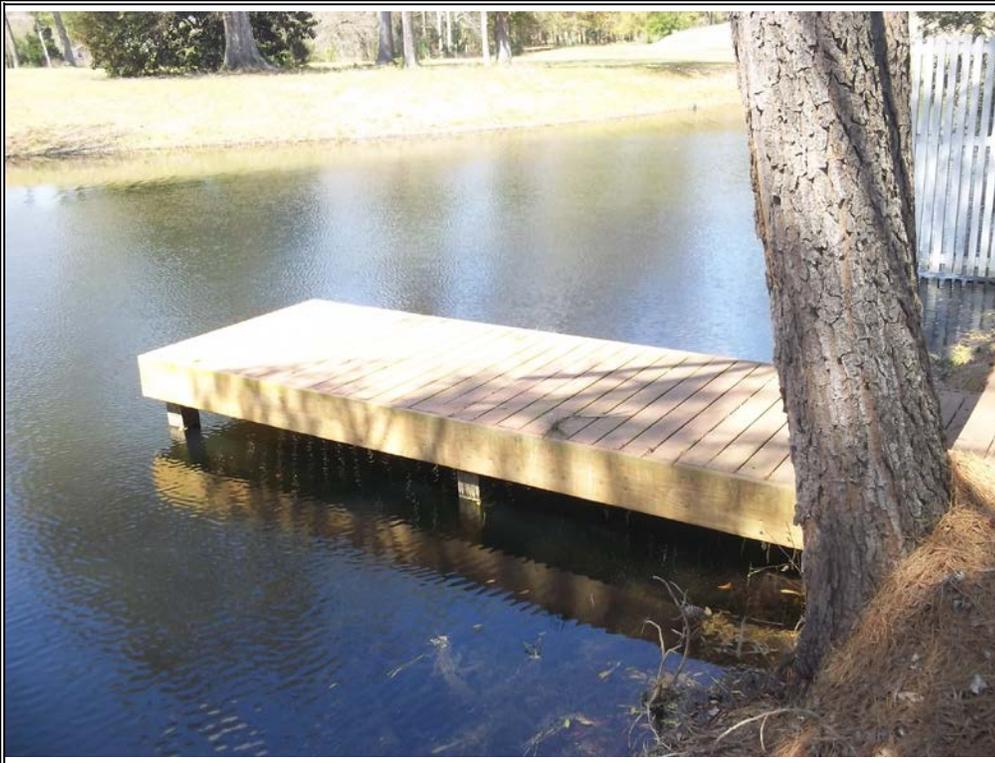
Photo Number
7

Description:
Small dock
adjacent to
clubhouse

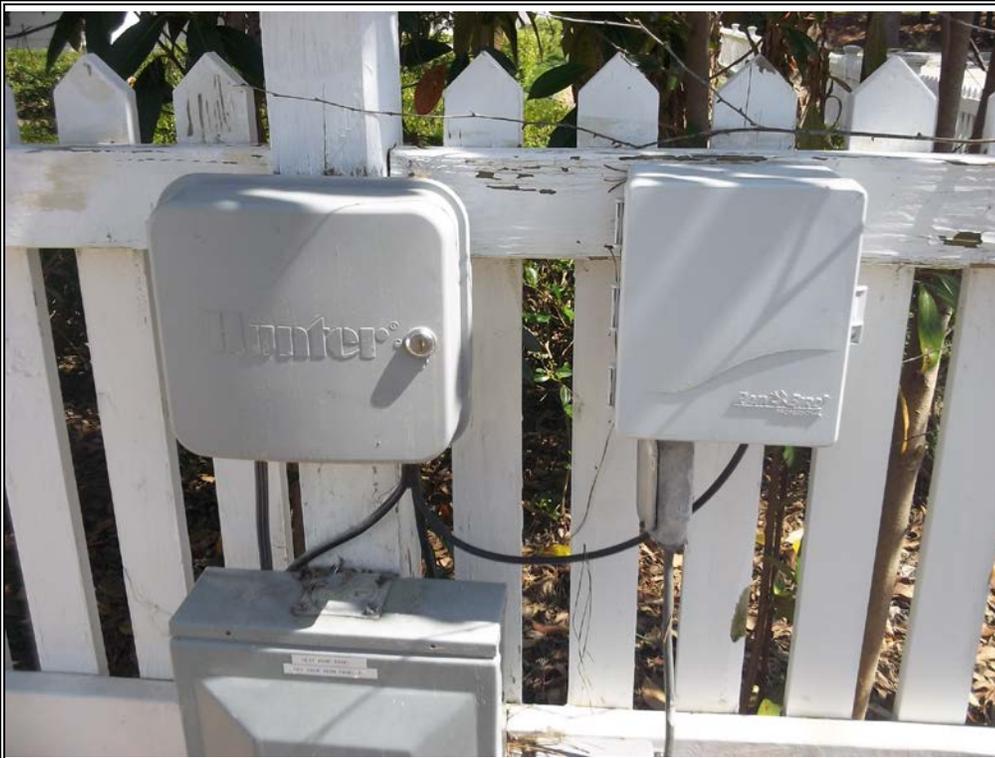
Photo Number
8

Description:
Irrigation
controller

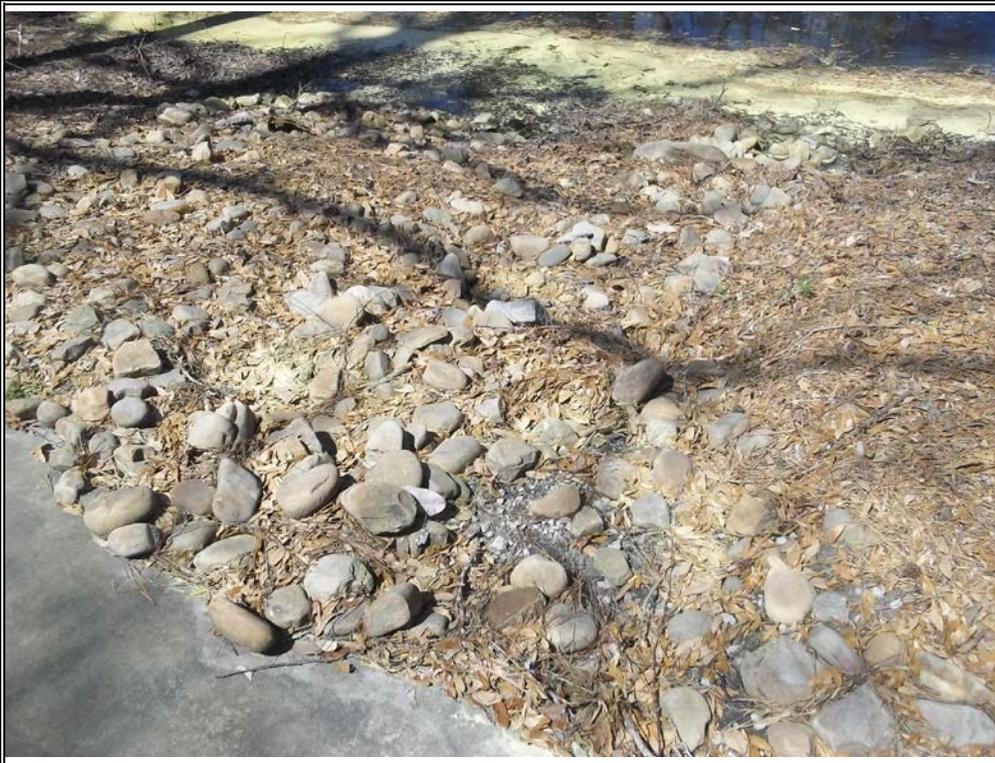
Photo Number
9

Description:
Rip rap erosion
control

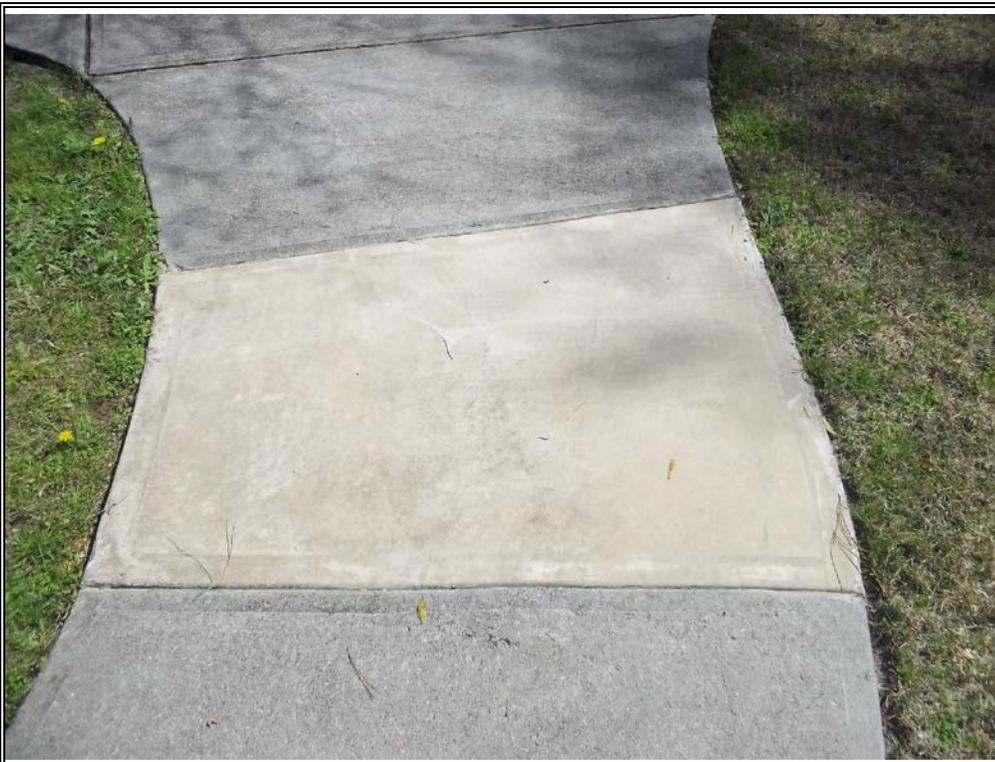
Photo Number
10

Description:
Previously
repaired section of
concrete flatwork

The association is responsible for maintaining the concrete sidewalks along the streets, pool deck, and concrete walkways in the common areas around the amenity center and at the shelters. The concrete flatwork generally appears to be in good condition. Cracking was noted in the pool deck and in the sidewalks with evidence of previous crack repairs as well as replacement of sections of sidewalks. We have included funds for replacement of sections of concrete flatwork every 8 years beginning in 2022, assuming approximately 2% of the total area is replaced during each cycle.

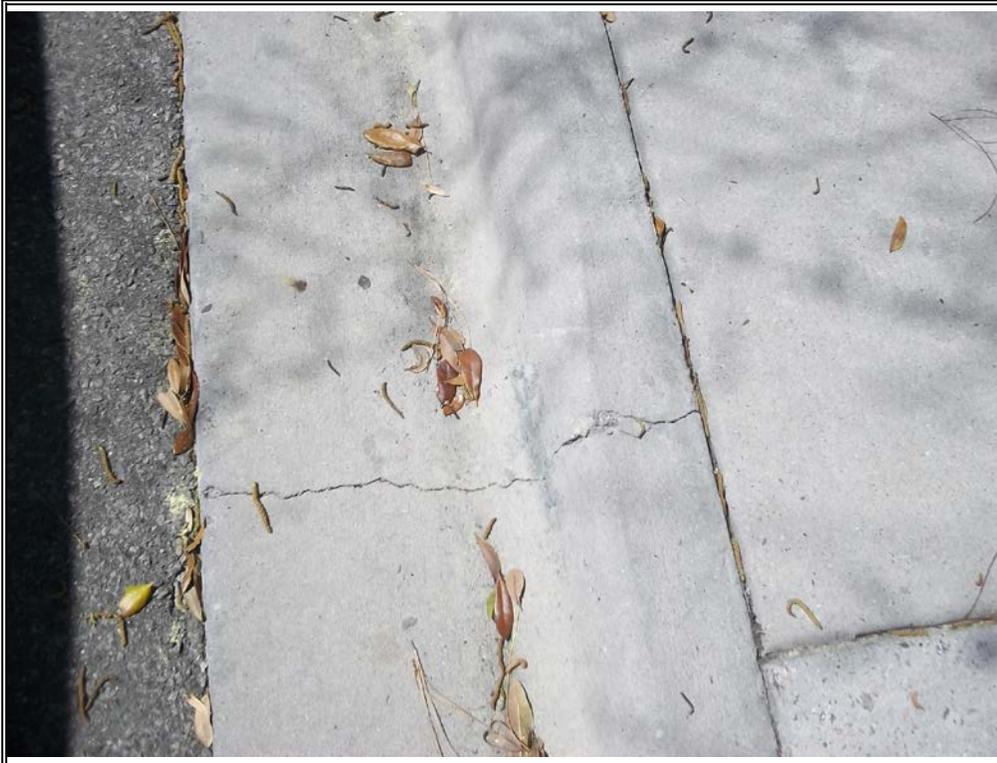
Photo Number
11

Description:
Minor cracking in
concrete curbing

Concrete curbing consist of standard curb and gutter and rolled curbing along the streets in the community. In addition, there are concrete wheel paths along the alleys behind rows of housing providing access. The concrete curbing and wheel paths generally appear to be in good condition with limited cracking and minor vertical displacement. It is likely that due to differential settlement, cracking will continue to develop and sections of the concrete curb will require replacement on an approximately 8 year cycle. We have allocated funds to repair roughly 2% of the total amount of concrete curbing every 8 years, beginning in 2022.

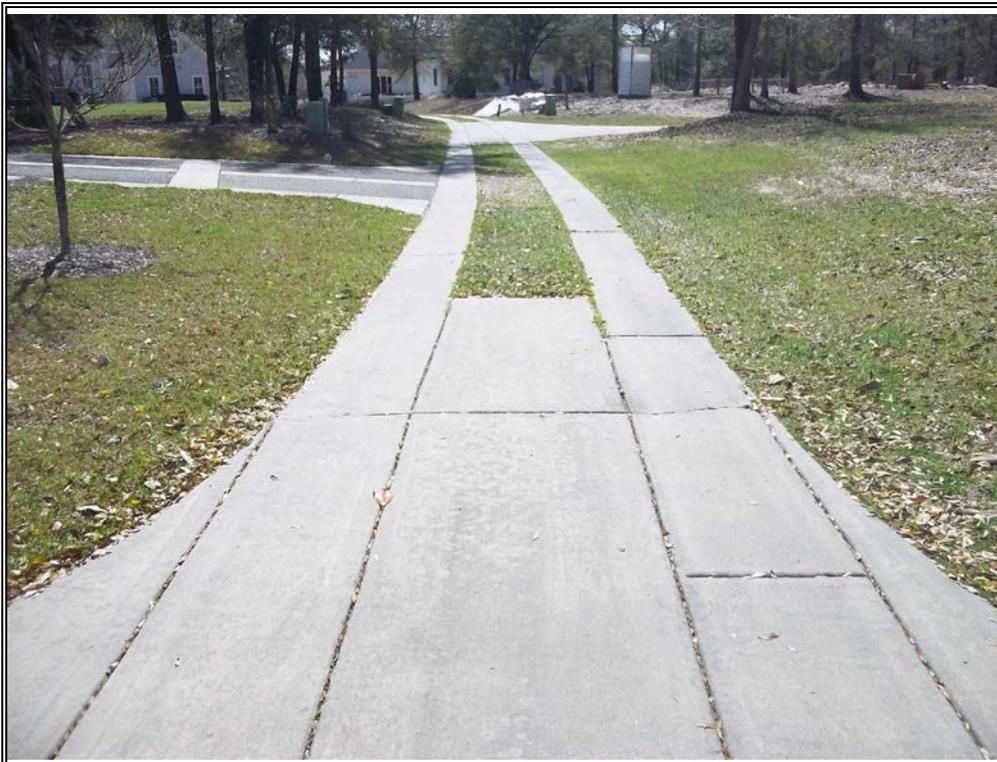
Photo Number
12

Description:
Concrete flatwork
leading to concrete
wheel paths in
alleys behind units

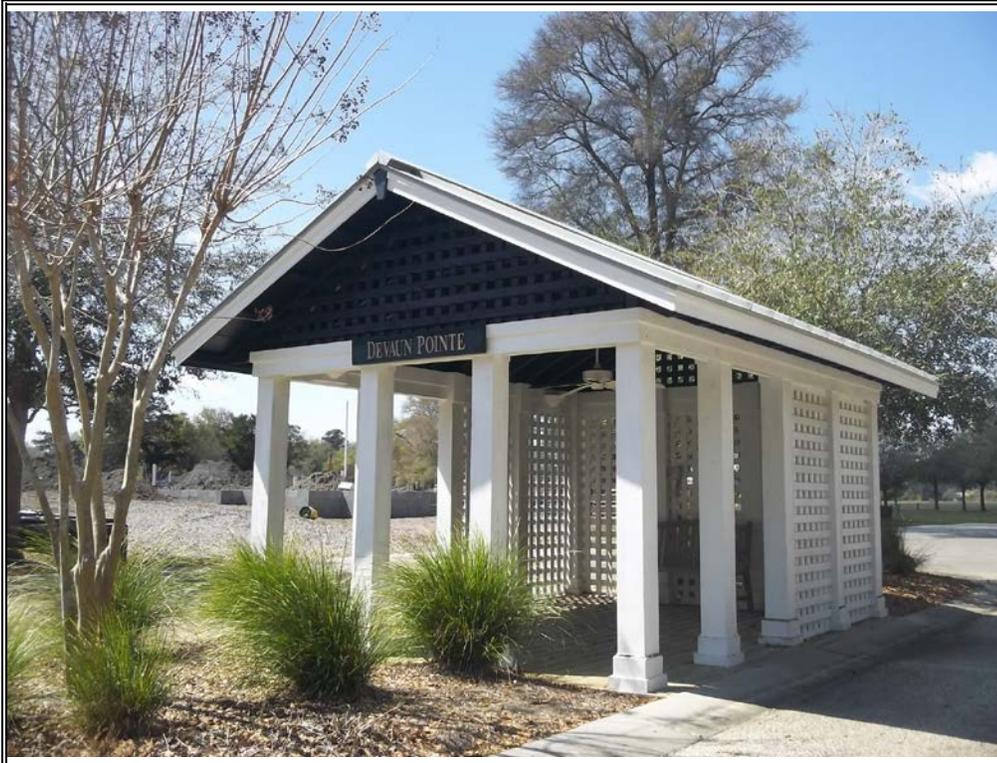
Photo Number
13

Description:
Typical shelter

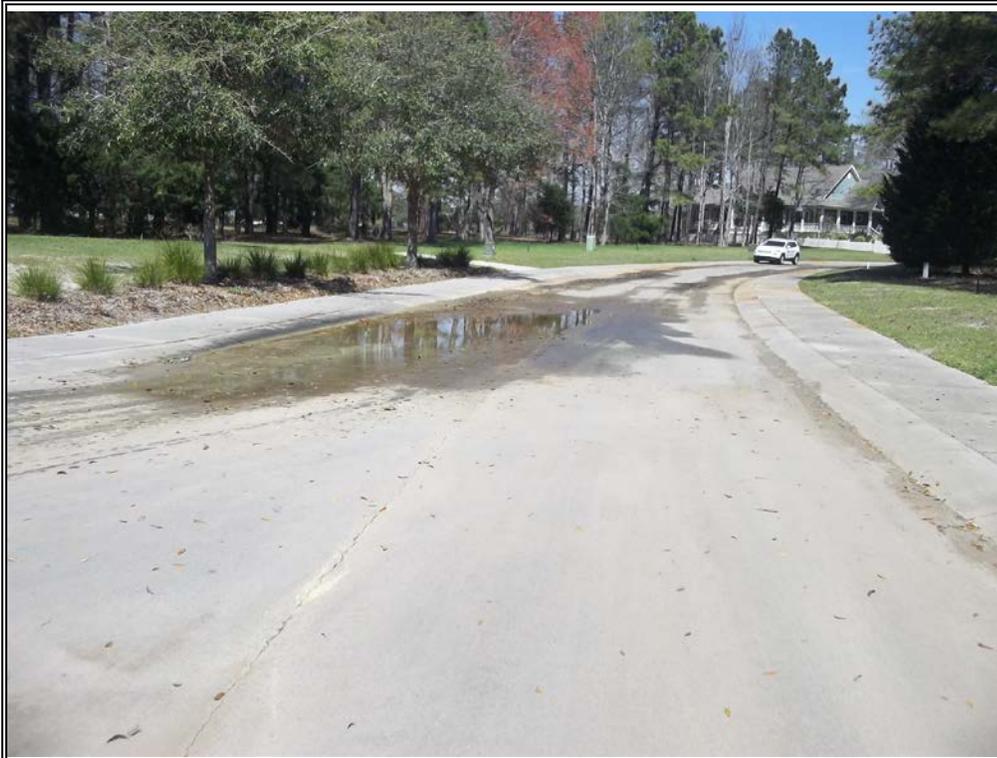
Photo Number
14

Description:
Water ponding in
roadway

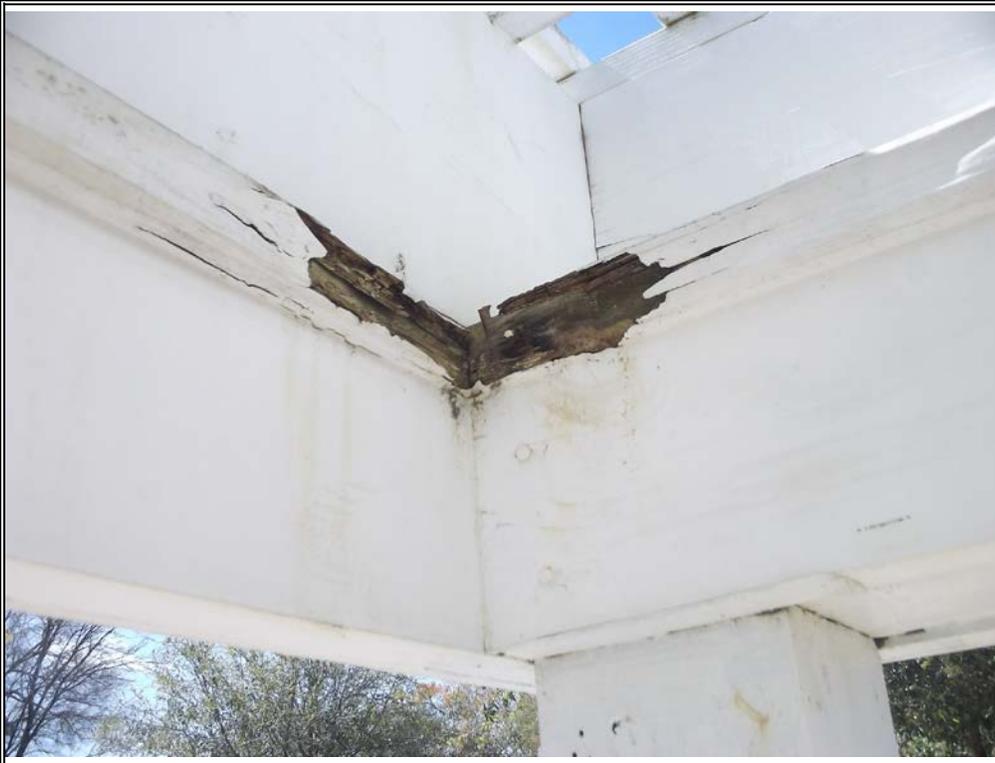
Photo Number
15

Description:
Minor
deterioration in
shelter

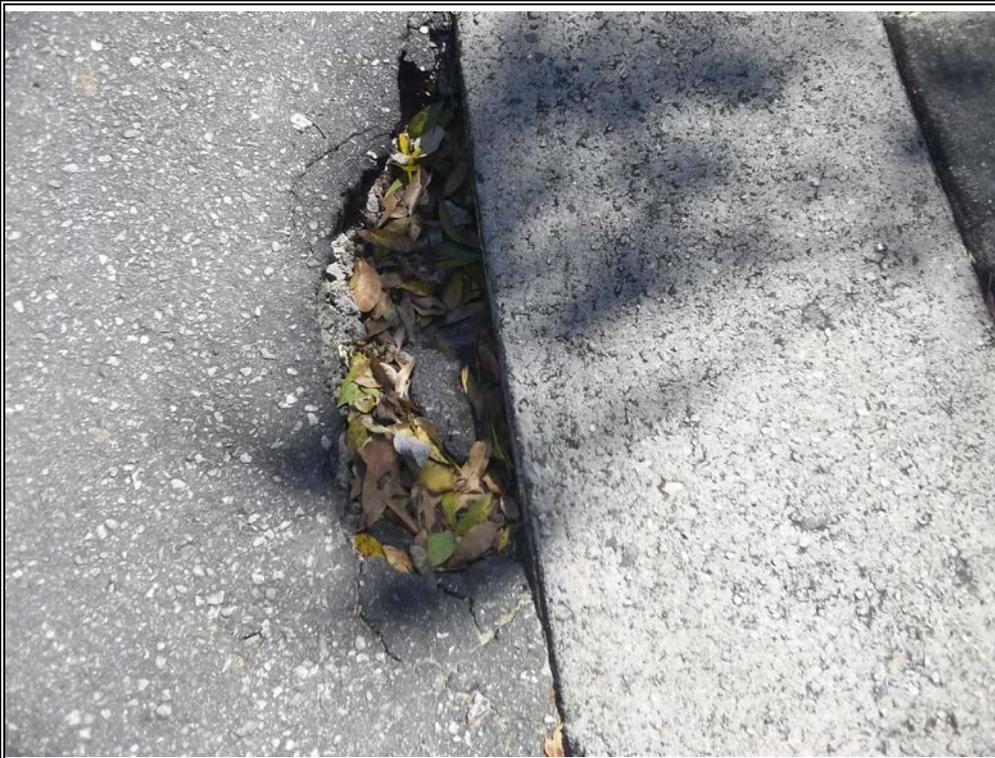
Photo Number
16

Description:
Asphalt depression

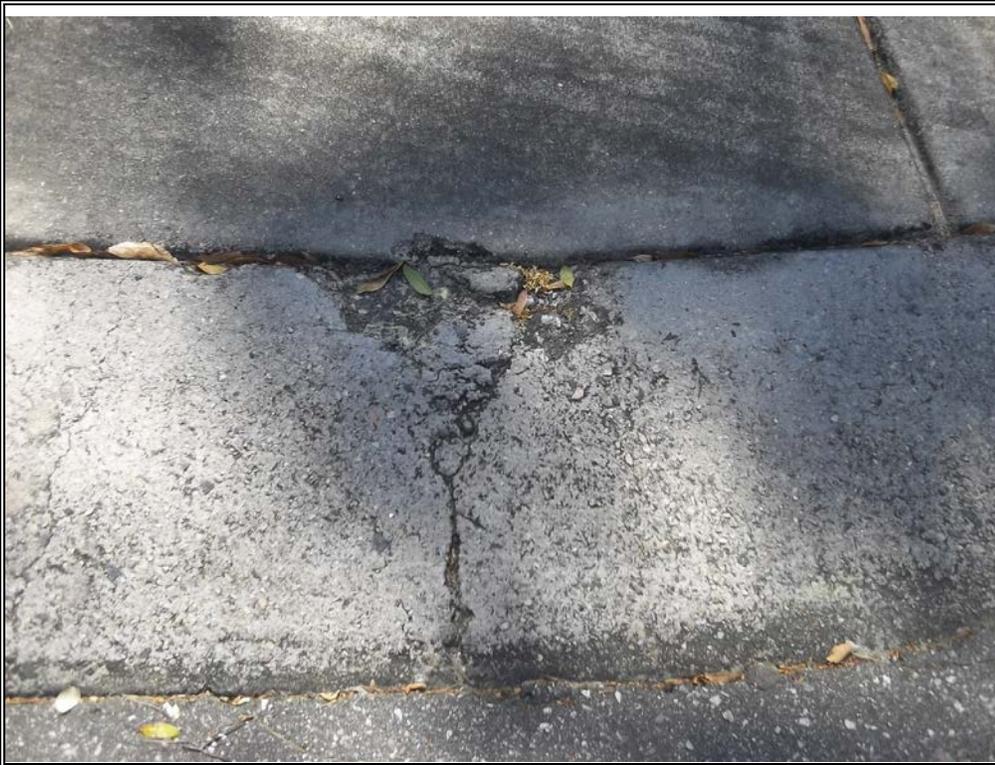
Photo Number
17

Description:
Concrete curbing
deterioration

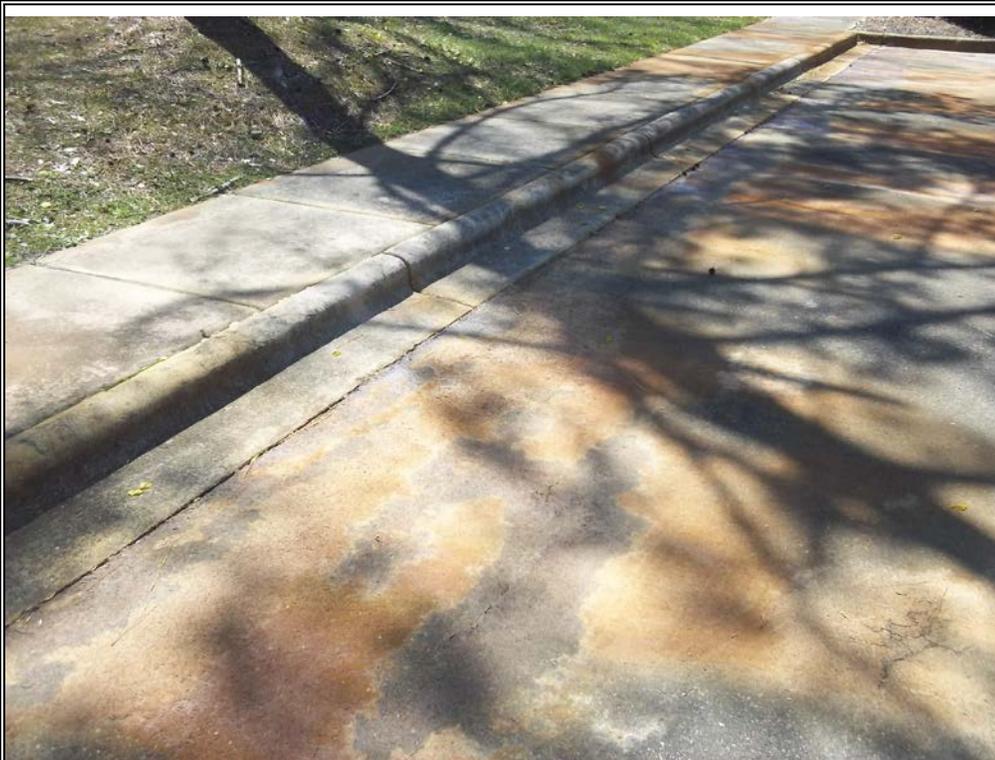
Photo Number
18

Description:
Seepage from
uphill areas
through curb

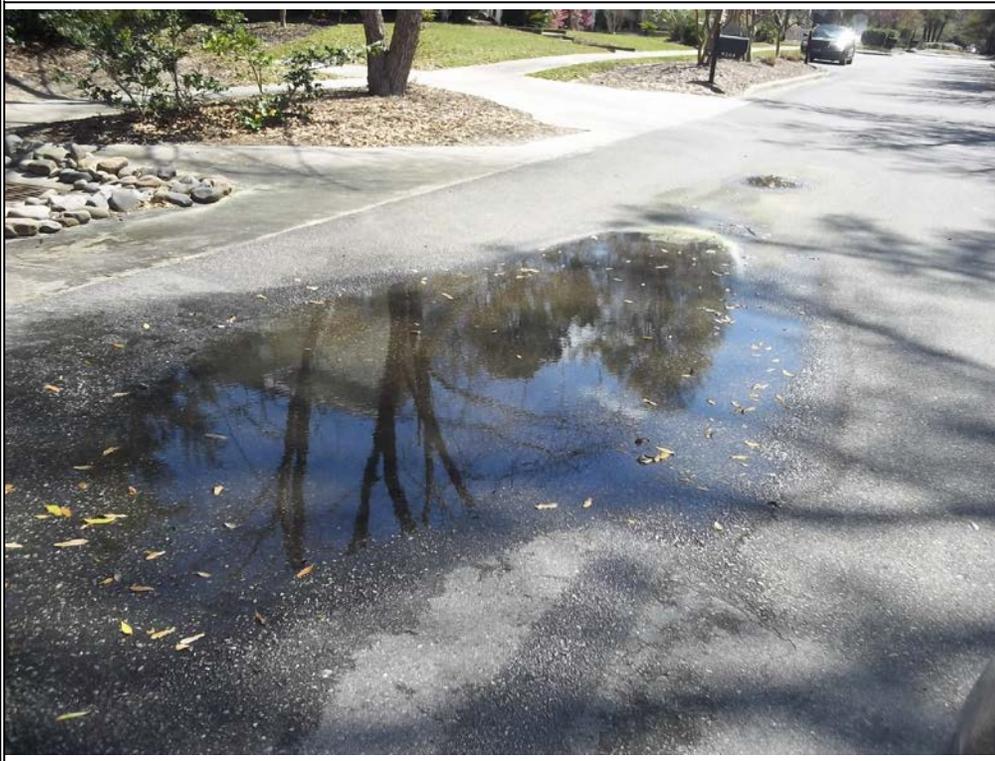
Photo Number
19

Description:
Ponding in
roadway, typical

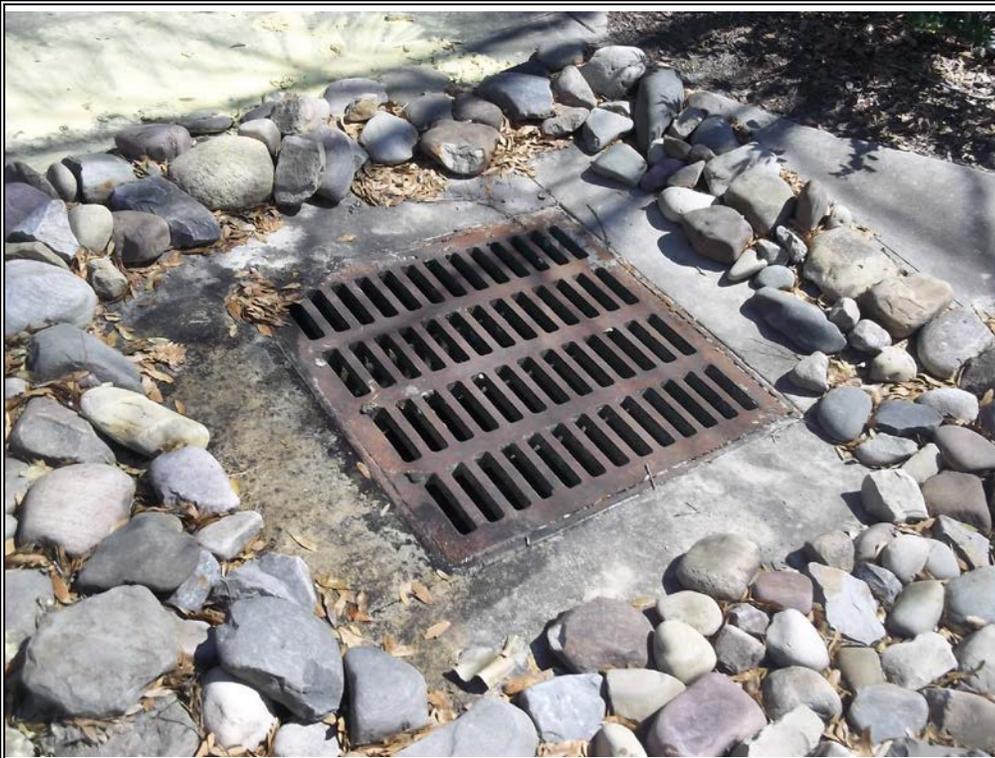
Photo Number
20

Description:
Typical drop inlet

swales will also require periodic repairs. The swales tend to accumulate sediment that settles out during storm events and will need to be periodically removed and re-graded. The pipe networks need to be periodically flushed/repared. We have allocated funds to repair the drainage systems, including minor pond repairs, on a 4 year cycle beginning in 2020. Repairs will likely include retrenching of swales to improve flow, adding rip rap or vegetation to stabilize exposed or steep areas (mostly in the areas of the detention ponds), installing french drains or other types of minor drainage systems.

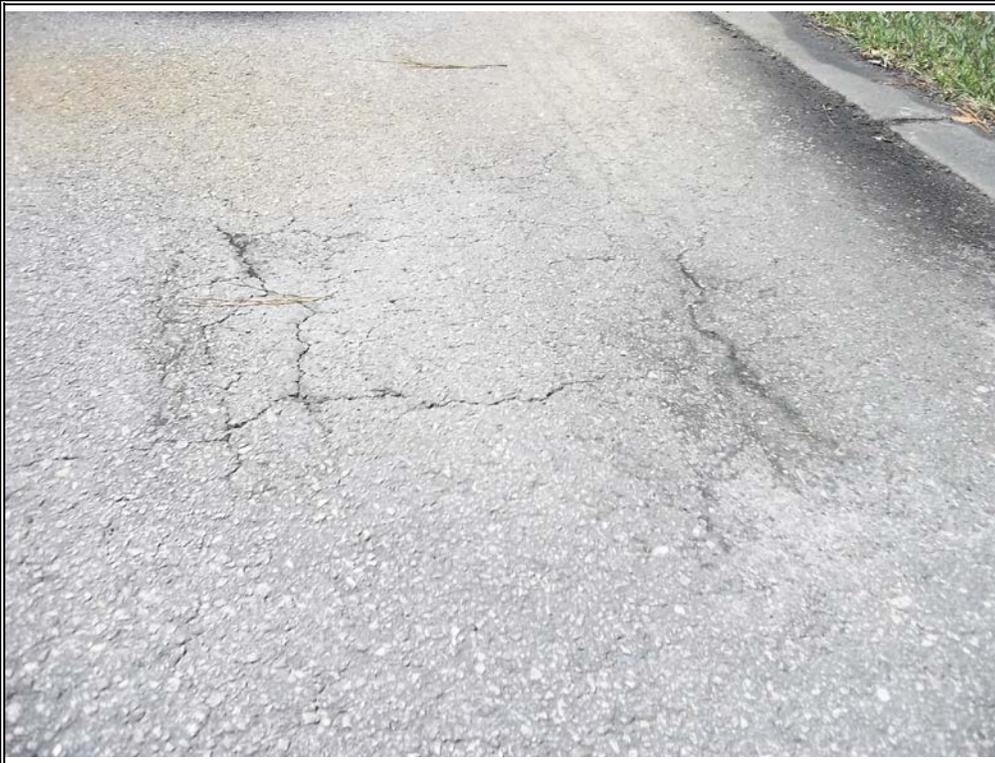
Photo Number
21

Description:
Small amounts of
fatigue cracking in
asphalt

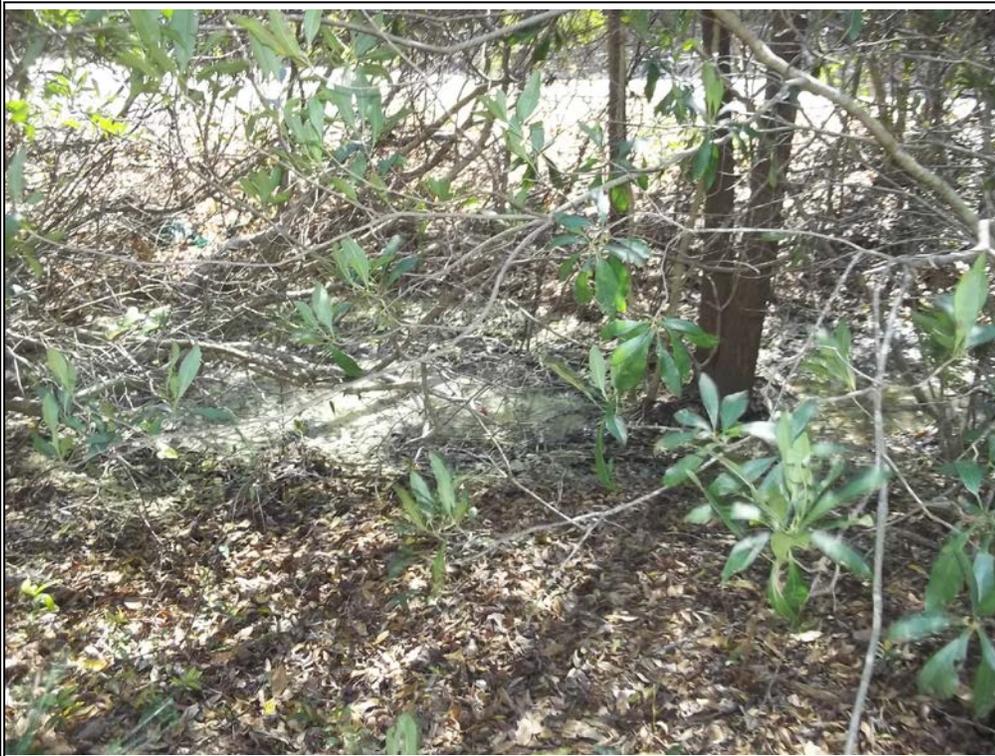
Photo Number
22

Description:
Discharge from
outlet pipe; future
location of
underground
storage

Once installed, the underground storage systems will need to have the pumps replaced and the sediment removed from the storage compartments. We have included funds to replace the pumps, clean out the sediment, and make other major repairs every 8 years beginning in 2025.

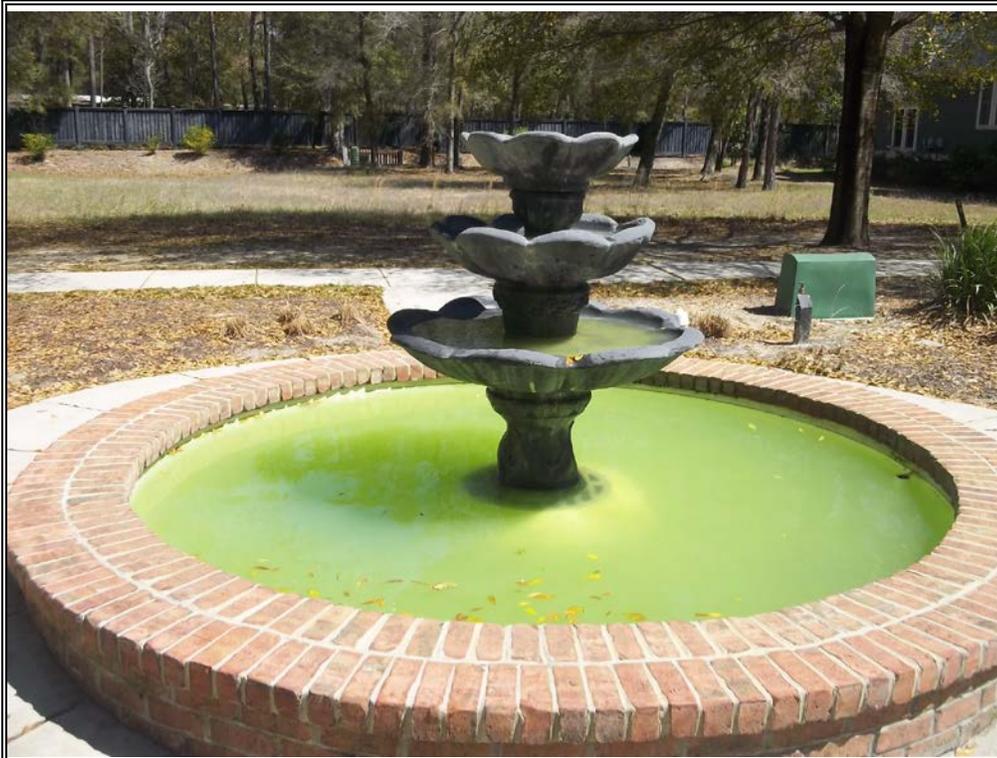
Photo Number
24

Description:
Small fountain

We have included funds to replace the 3 pond fountains every 6 years beginning in 2020.

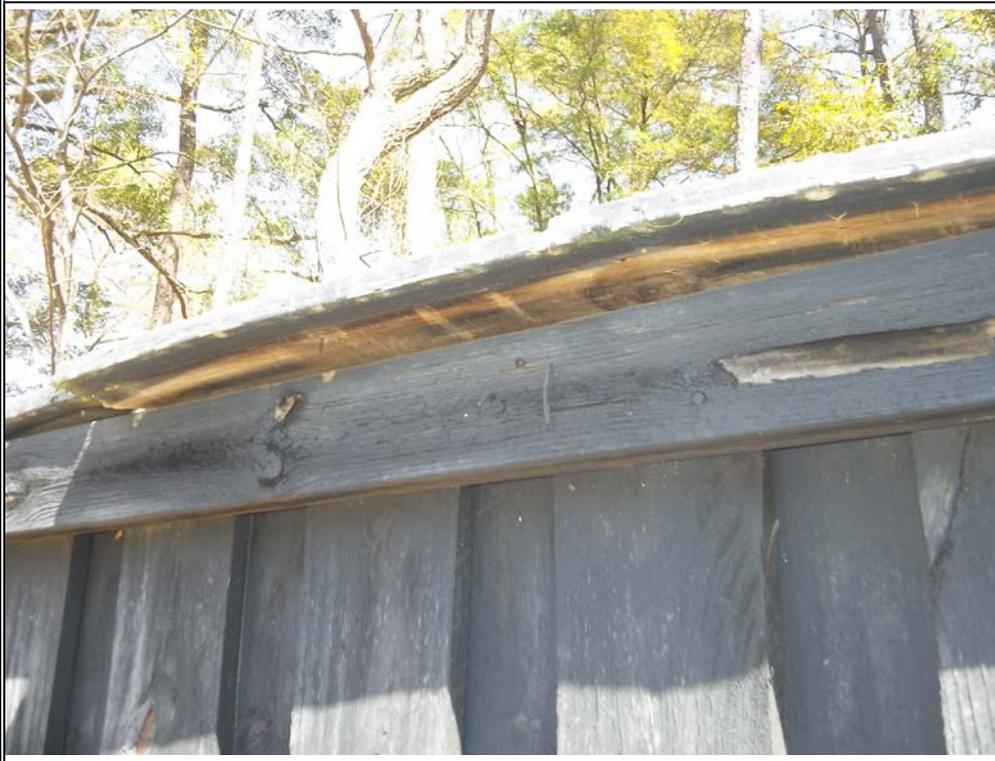
Photo Number
25

Description:
Association
maintained fence
along property
line; minor
warping and
deterioration of
boards

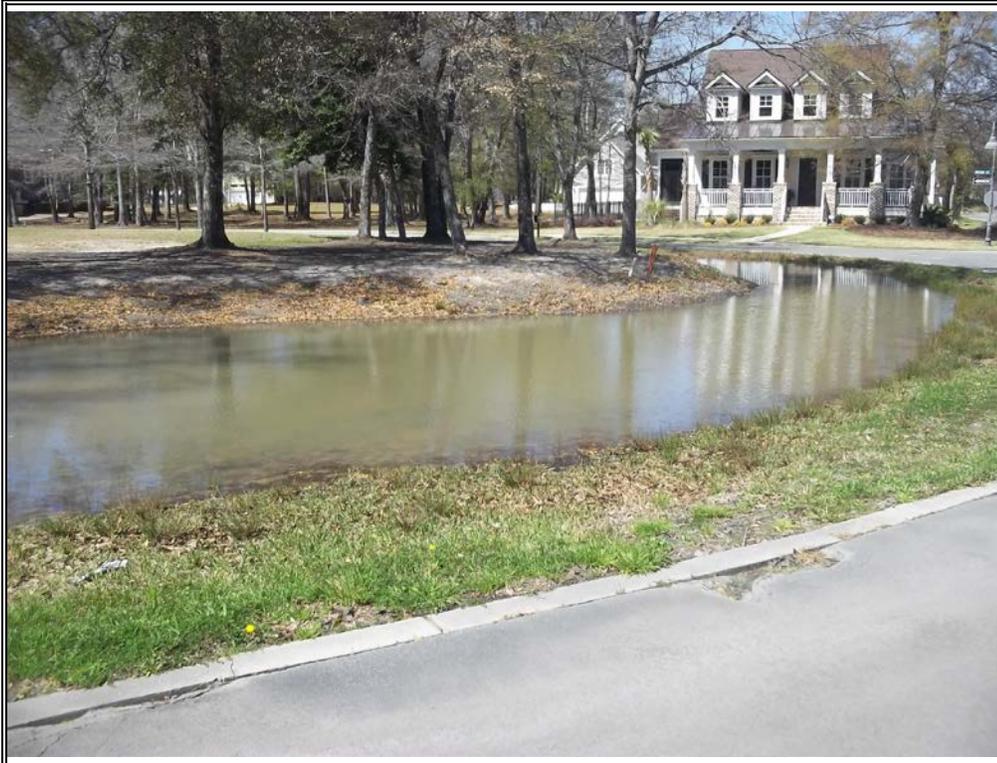
Photo Number
27

Description:
Ponding adjacent
to roadway

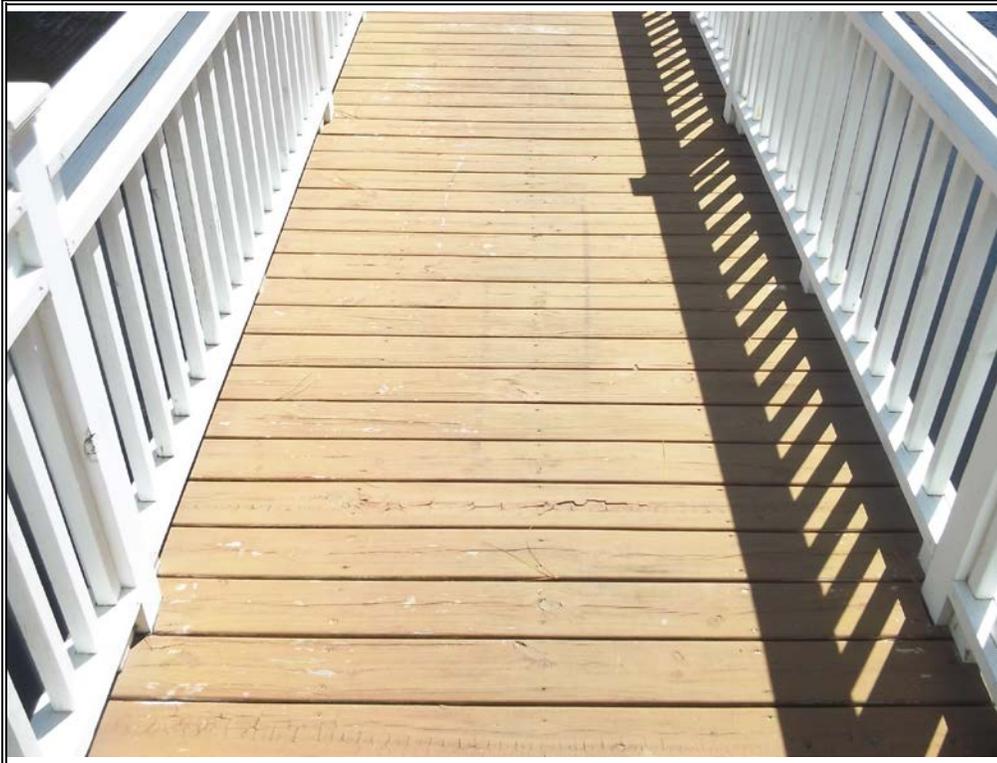
Photo Number
29

Wood boardwalks are located at both of the ponds, and include stained or painted wood rails and decking. The structure appears to be in good

condition, though the paint/stain finish has worn and is actively peeling. We have included an allowance to paint and make interim repairs to deck boards and rails/balusters every 5 years, beginning in 2019. We have included funds to replace the complete boardwalks every 25 years beginning in 2032.

Description:
Typical boardwalk

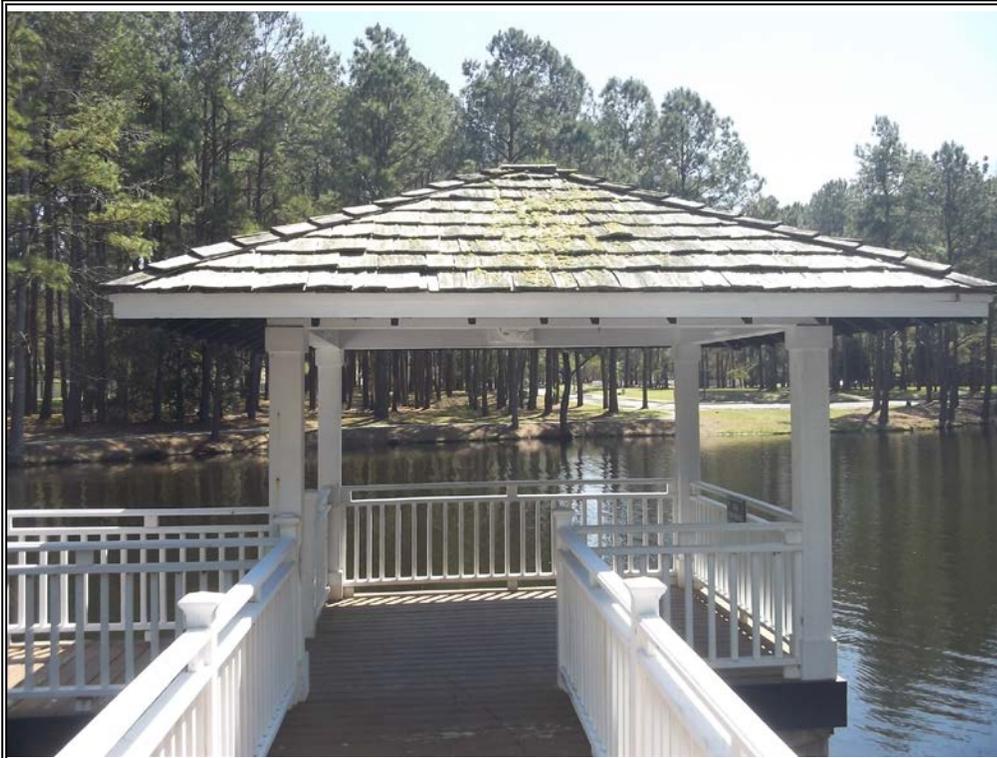
Photo Number
30

Description:
Typical
gazebo/shelter
