FULL RESERVE STUDY

*DEVAUN PARK
CALABASH, NC*

*Prepared for:
DEVAUN PARK COMMUNITY ASSOCIATION
CALABASH, NC
&
CAS, INC.*

JUNE 3, 2016

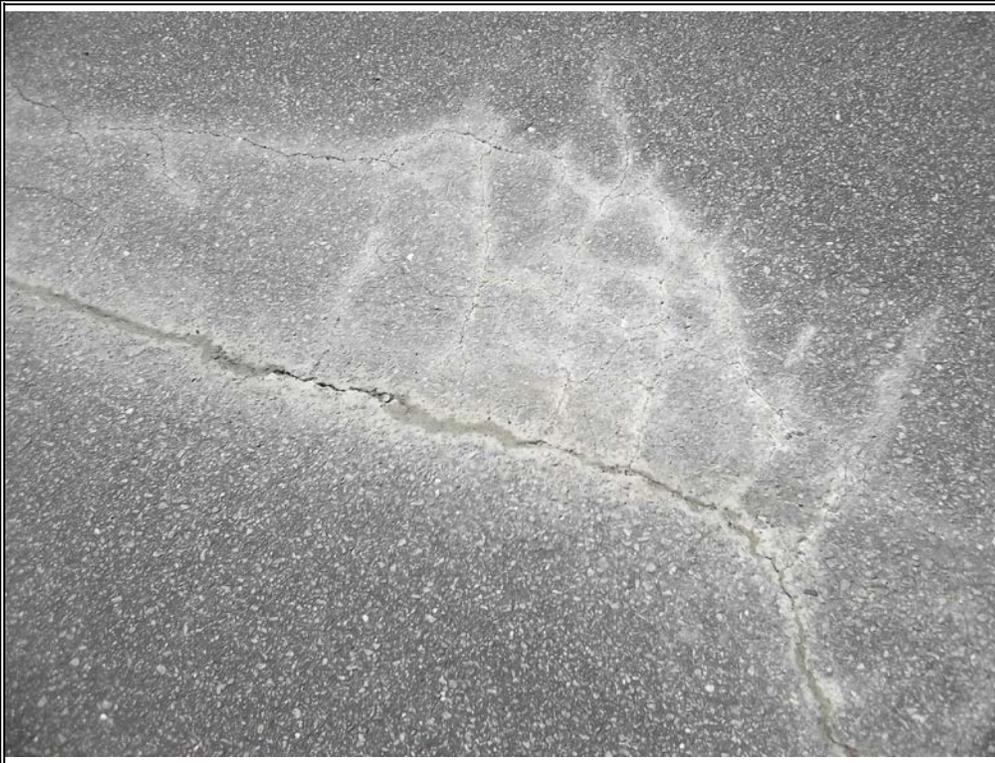
Photo Number
31

Description:
Seepage through
asphalt

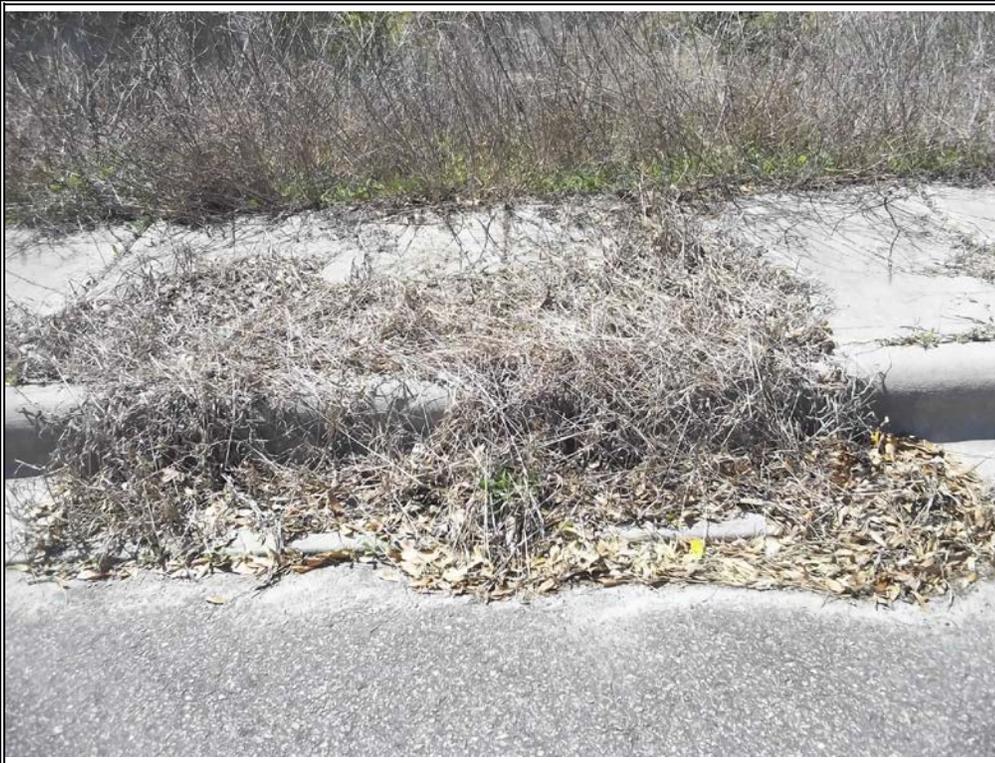
Photo Number
33

Description:
Deterioration due
to lack of use of
majority of area

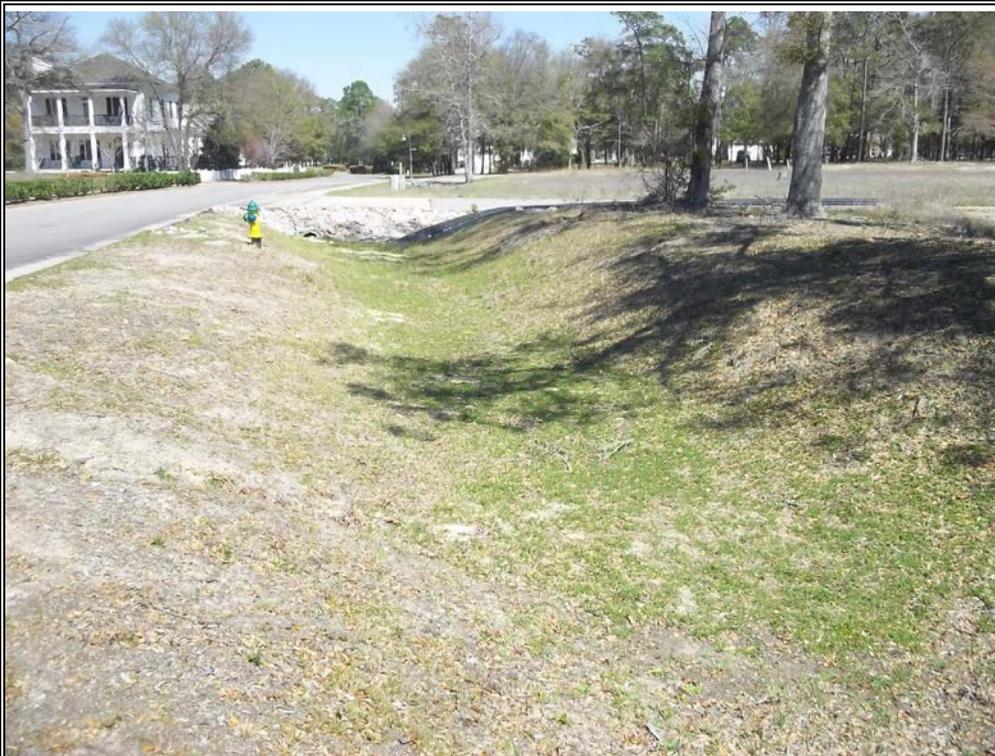
Photo Number
34

Description:
Typical swale in
community

swales will also require periodic repairs. The swales tend to accumulate sediment that settles out during storm events and will need to be periodically removed and re-graded. The pipe networks need to be periodically flushed/repared. We have allocated funds to repair the drainage systems, including minor pond repairs, on a 4 year cycle beginning in 2020. Repairs will likely include retrenching of swales to improve flow, adding rip rap or vegetation to stabilize exposed or steep areas (mostly in the areas of the detention ponds), installing french drains or other types of minor drainage systems.

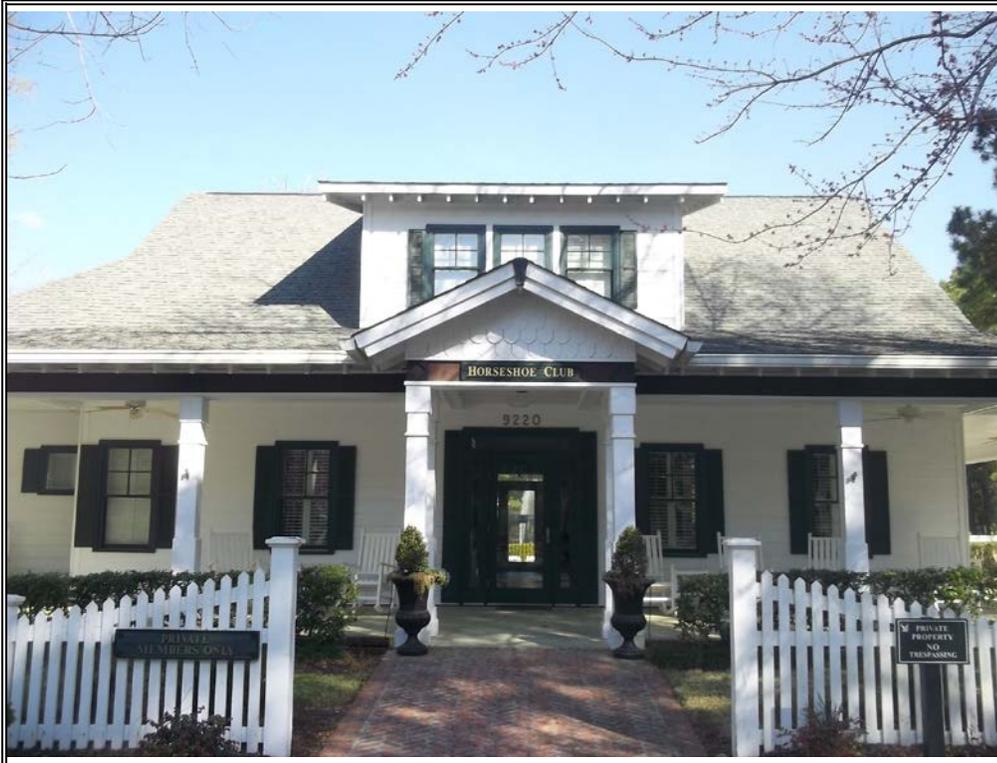
Photo Number
35

The wood-framed clubhouse and pool building exteriors are primarily clad in fiber cement (Hardiplank) siding and trim with sections of wood and aluminum trim. The building exterior is generally in fair condition, with no known previous painting. The caulking is cracked in several areas, and the paint is faded. We have included funds to paint the building exterior of both buildings every 7 years beginning in 2018.

Description:
Clubhouse

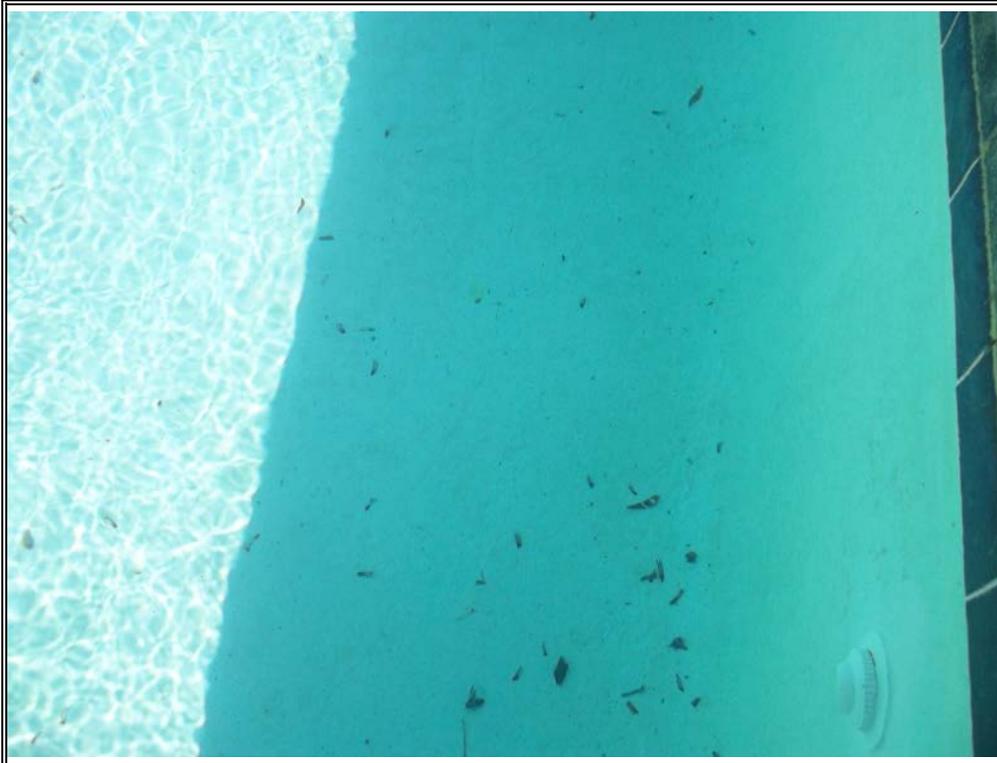
Photo Number
39

Description:
Minor cracking at
surface

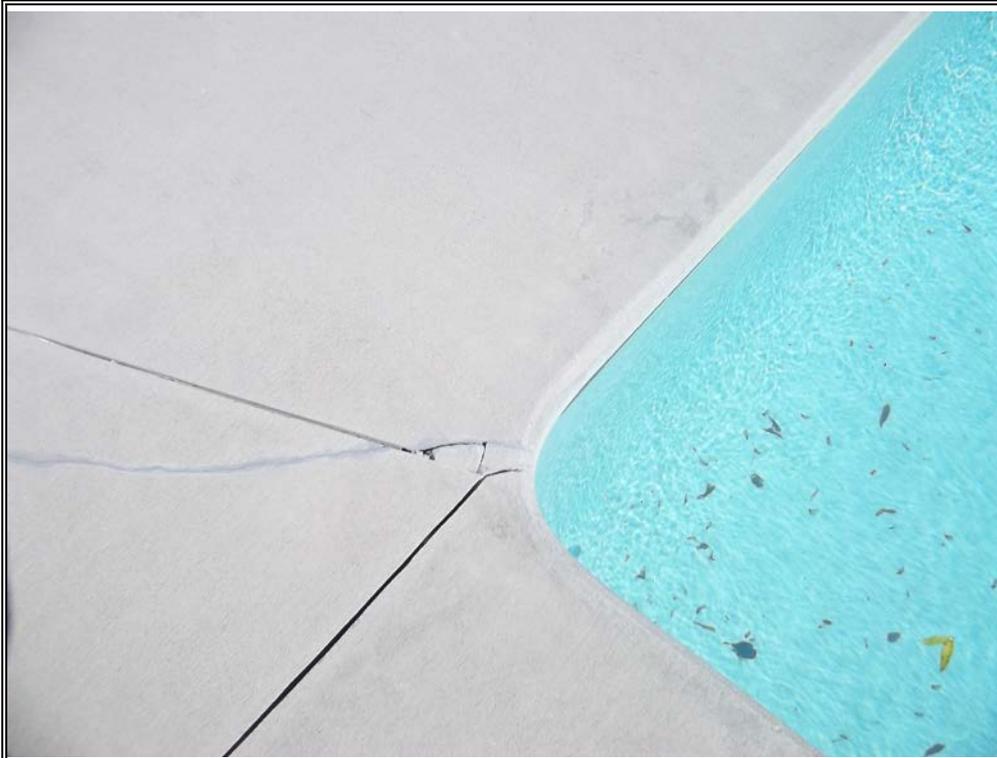
Photo Number
40

Description:
Crack repairs
noted

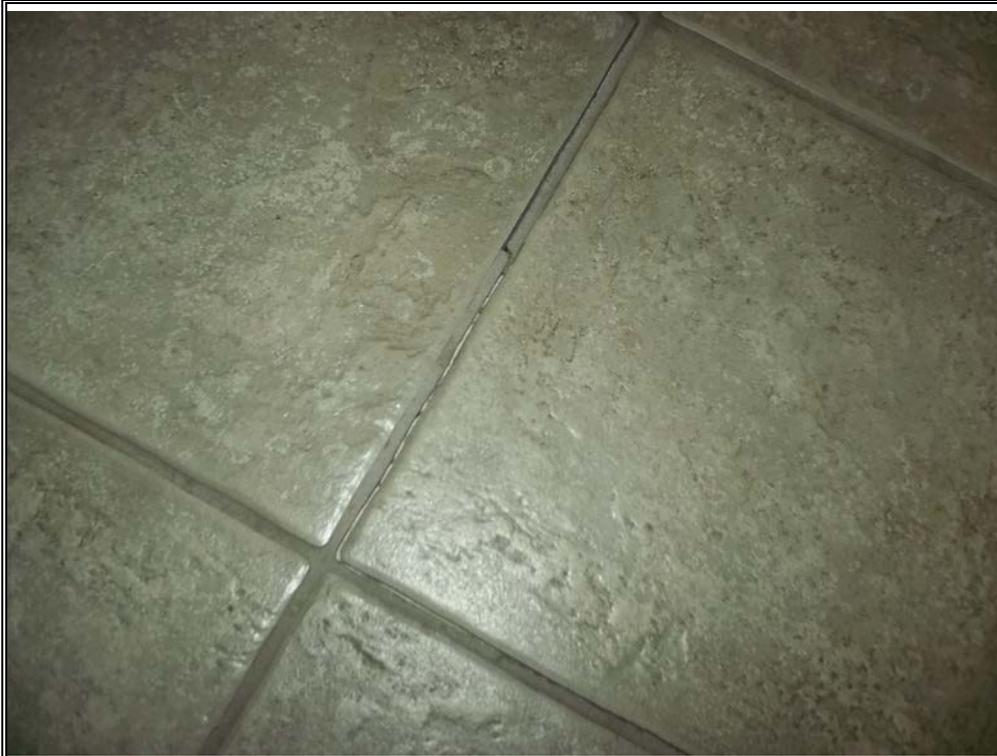
49

The ceramic tile is in good condition, with some minor cracking in the joints noted in the kitchen. Updating will likely be required every 20 years, beginning in 2026. We have assumed only ½ will be replaced at any given time.

Minor cracking in
tile floor

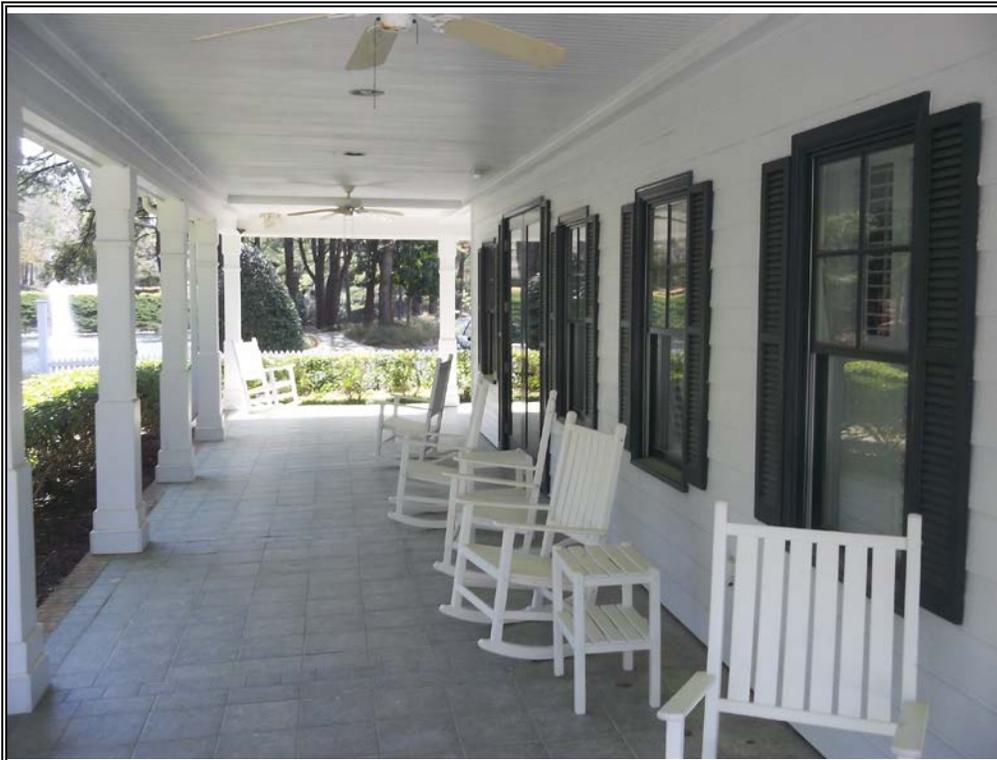
Photo Number
54

The exterior perimeter of the clubhouse below the overhang is provided with a ceramic tile flooring. Exterior tile flooring has a tendency to require repairs after becoming dislodged, though none were observed during the inspection. These minor repairs should be repaired out of a general operating budget. However, replacement of the tile flooring will likely be required approximately every 20 years, beginning in 2027.

Description:
Exterior of
clubhouse under
porch
